Manhole Inspection Summary

Manhole # S23O1_006MH

Insp Date: **6/23/08 10:15 AM**

Location Address: **3360 Annapolis Rd.**

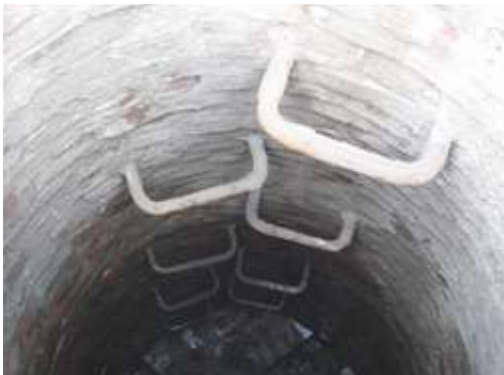
Steps

Count: **8** Missing: **1** ☒ **Corroded**

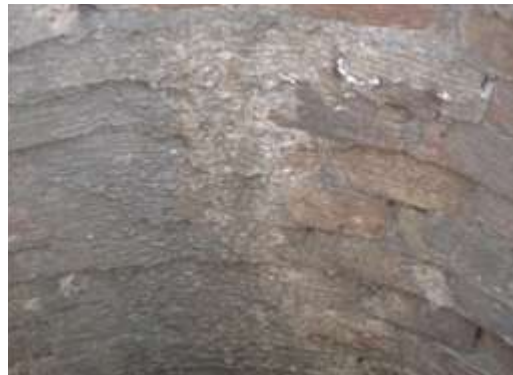
Defect 2

Infiltration: ☐ None ☐ Joint ☐ Cracks ☐ Mortar ☐ Roots ☒ **Wall**

Infiltration

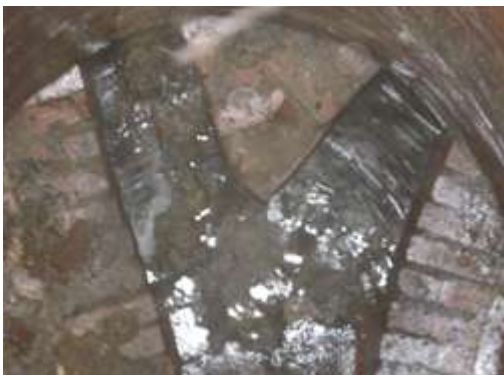
Defect 1

Condition: ☐ Sound ☐ Cracked ☐ Root Intrusion ☐ Deteriorated ☐ Leaks ☒ **Debris**

Channel blockage

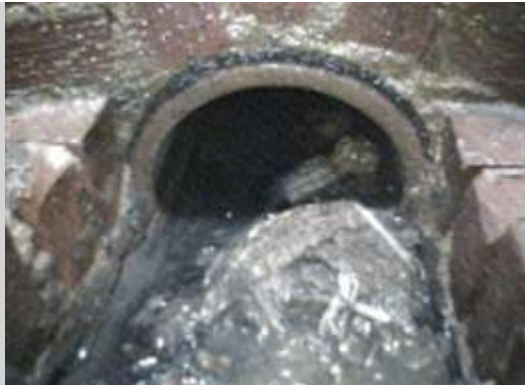
6 O'Clock Inflow

Deposits: ☐ None ☐ Mud ☒ **Sludge** ☐ Debris ☐ Grease

Silt Depth: **4** (in.) Deposits Extent: **Medium**
